CORNER RECORD

City of BERKELEY

Brief Legal Description CITY OF BERKELEY MONUMENT B0689

BK 49 PG 70
Document Number CR 5442
County of ALAMEDA, California

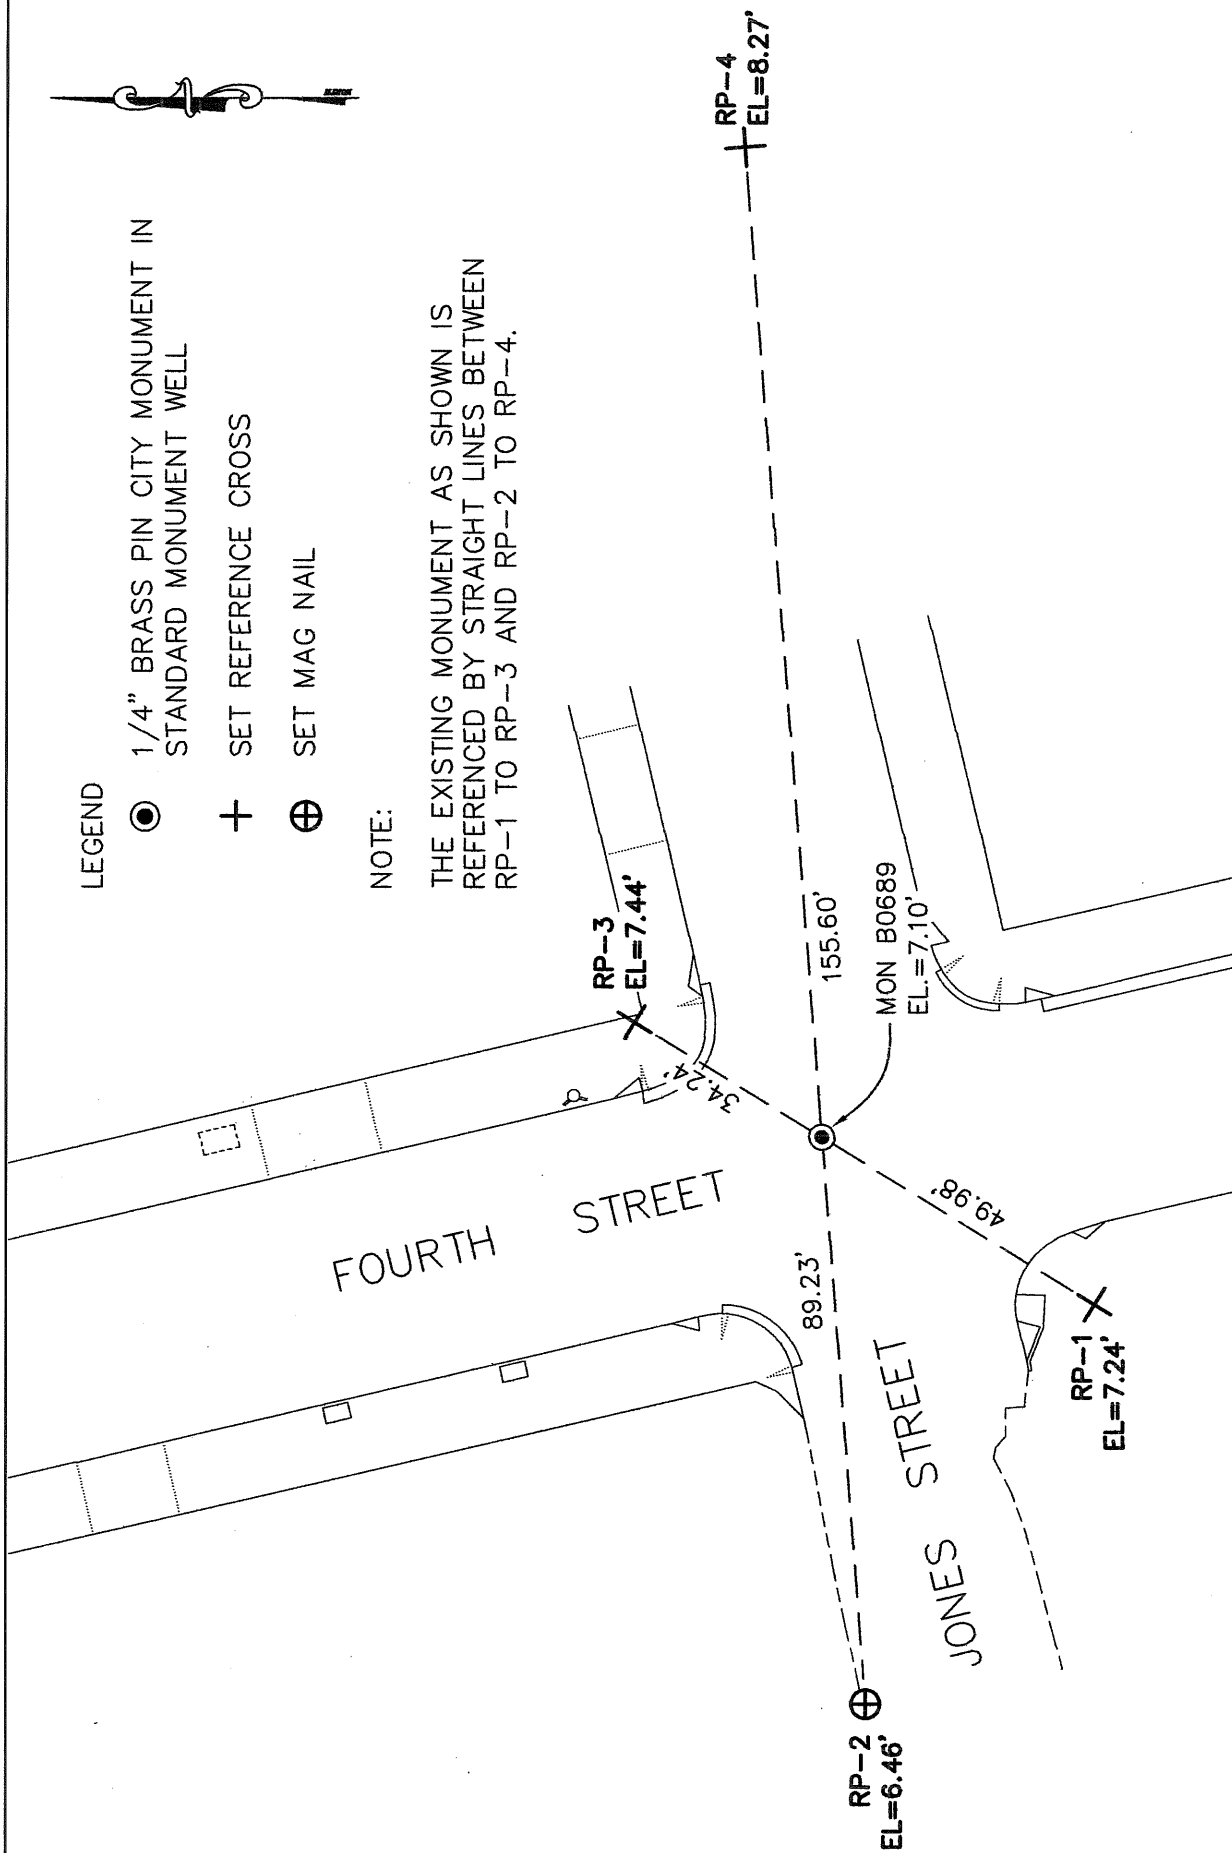
A description of the physical condition of the monument as found and as set or reset:
CITY OF BERKELEY STANDARD WELL-TYPE MONUMENT, FOUND IN GOOD CONDITION. (SEE PAGE 2)

THE EXISTING MONUMENT AS SHOWN IS
REFERENCED BY STRAIGHT LINES BETWEEN
RP-1 TO RP-3 AND RP-2 TO RP-4.
